xx Sleepy Hollow Drive, Sugar Land, Fort Bend, TX, 7xxx9

General Info

Effective Date	08/01/2020	Inspection Date	08/18/2020
Policy Number	xxx10079563-00	Policy Status	new
Policy Type	E&S Multi-Peril	Inspection Type	All Inclusive Inspection
Policy Holder	Claire xxx	Home Phone	832242xxxx
Property Street	xxx Sleepy Hollow Drive	Contact Phone	832242xxxx
Property City	Sugar Land	Business Phone	
Property State	TX	Email	
Property Zip Code	7xxx9	Company	xxx Insurance Agency
AOP Deductible	1,000	Agent	Matt xxx
Wind Deductible		Agent Phone	
System	XXX	Policy Company	Insurance Company

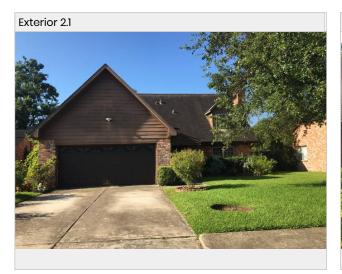
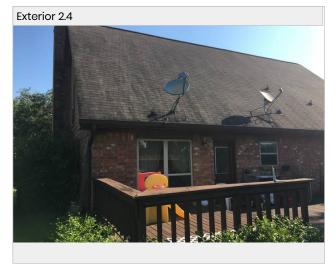
Inspection Question	Current Information	Inspector Update	Χ	Additional Information
10 Square Footage	1980	1980		Online lookup
11 Construction Type	Brick Veneer	Frame	Χ	
12 Wind Mitigation	no protection	No Protection		
13 Screen Enclosure	n			
14 Exterior Coating		Veneer

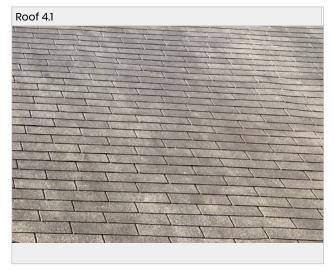
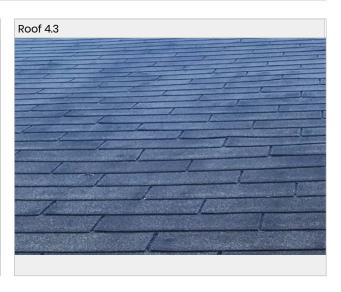
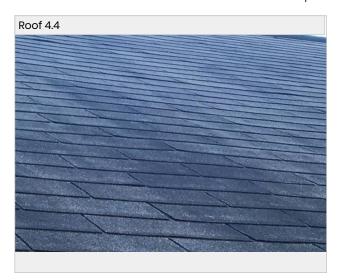
Inspection Question	Current Information	Inspector Update	Χ	Additional Information
16 Roof Type	Shingle	Shingle		
17 Roof Geometry	hip	Gable	Χ	
18 Roof Year	2011			
19 Roof Condition		Fair		Some aging present
20 Hurricane Straps	unknown	None	Χ

Shingles look much older than 2011

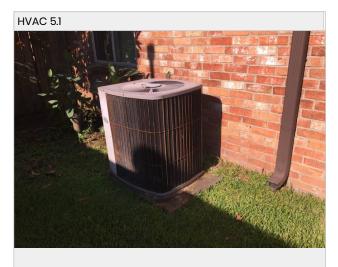
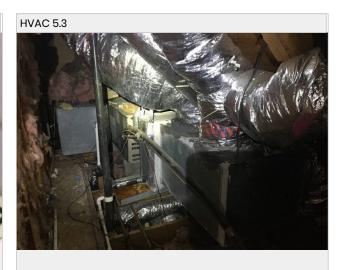
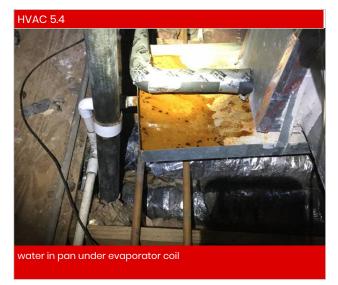
Inspection Question	Current Information	Inspector Update	Χ	Additional Information
21 Heating System		Gas furnaces		
22 Heating Update	у	Yes		
23 Heating Year	2015	1993	Χ	Documents viewed
24 Central A/C		Yes		
25 Central A/C Year		1992	Χ	
26 A/C Units	у	1		
27 A/C Year Unit 1	2015	1992	Χ	
28 A/C Year Unit 2	unknown			
29 A/C Year Unit 3				
30 A/C Window Units

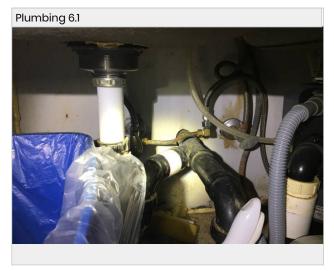
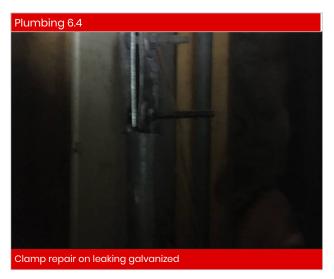
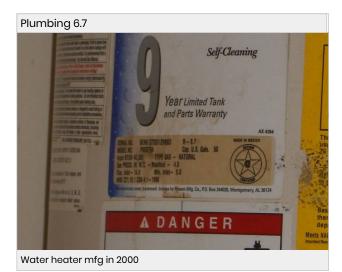
Inspection Question	Current Information	Inspector Update	Х	Additional Information
31 Plumbing Type		Other	Х	
32 Plumbing Update	у	No	X	
33 Plumbing Year	1995	1979	X	
34 Water Heater location

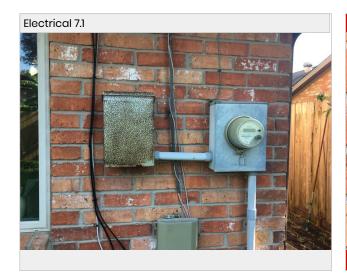
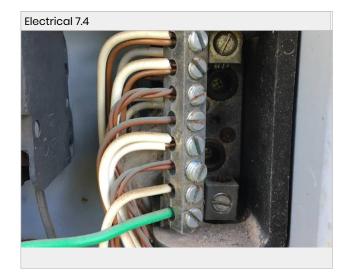
Inspection Question	Current Information	Inspector Update	Χ	Additional Information
35 Wiring Type		Copper		
36 Wiring Update	у	No	Χ	
37 Electrical Panel		Federal Pacific Electric (FPE)	Χ	
		panels		
38 Wiring Year	1995
