xxx Governor Nicholls Street, New Orleans, Orleans, LA, 7xxx6

General Info

Effective Date	09/04/2020	Inspection Date	09/21/2020
Policy Number	xxx10081803-00	Policy Status	new
Policy Type	E&S Multi-Peril	Inspection Type	All Inclusive Inspection
Policy Holder	Anna xxx	Home Phone	337298xxxx
Property Street	xxx Governor Nicholls Street	Contact Phone	337298xxxx
Property City	New Orleans	Business Phone	
Property State	LA	Email	
Property Zip Code	7xxx6	Company	xxx Insurance Services, Inc.
AOP Deductible	2,500	Agent	Amelia xxx
Wind Deductible		Agent Phone	
System	XXX	Policy Company	Insurance Company

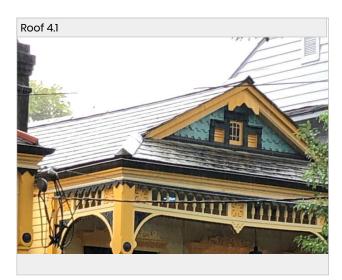
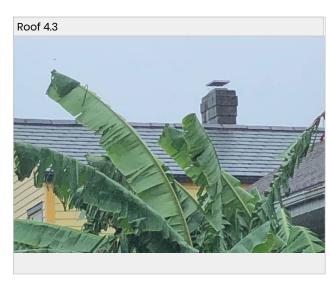
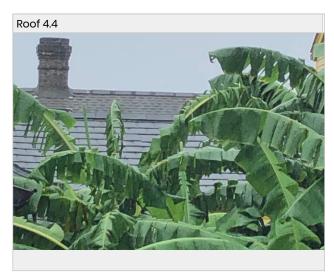
Inspection Question	Current Information	Inspector Update	Χ	Additional Information
16 Roof Type	Shingle	Slate	Х	
17 Roof Geometry	gable	Gable		
18 Roof Year	2012			
19 Roof Condition		Excellent		
20 Hurricane Straps	unknown	Toe Nails	Χ

Portions of the roof are not visible/accessible.

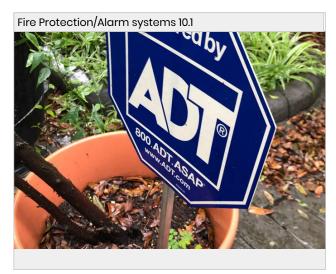
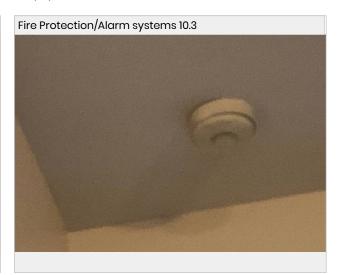
This house is protected by ADT
