xxxxx Southeast Federal Highway, Tequesta, Martin, FL, 3xxx9

Demo Arc Page 1/18

Effective Date	01/22/2021	Inspection Date	01/29/2021
Policy Number	xxx10089972-00	Policy Status	new
Policy Type	E&S Multi-Peril	Inspection Type	All Inclusive Inspection
Policy Holder	Jordan xxx	Home Phone	772631xxxx
Property Street	xxxxx Southeast Federal Highway	Contact Phone	772631xxxx
Property City	Tequesta	Business Phone	
Property State	FL	Email	
Property Zip Code	3xxx9	Company	xxx Agent Group
AOP Deductible	2,500	Agent	Betty xxx
Wind Deductible		Agent Phone	(561)775-xxxx
System	XXX	Policy Company	Insurance Company

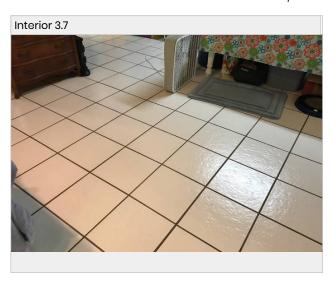
There is a lot of junk/stuff inside the house. It is organized but it is still an extensive amount of stuff

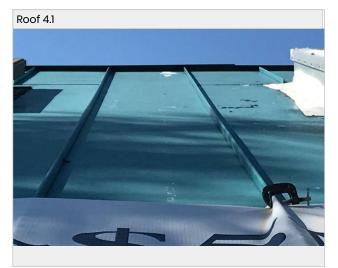
No access to attic. The roof uses three different materials metal, shingle and membrane. Gable structure.

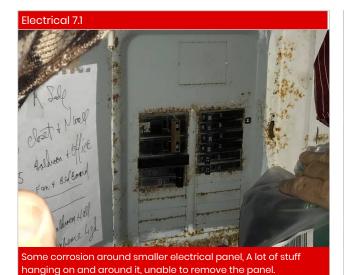
Electrical panel is Federal Pacific, it was last inspected in the year 2012. The panel is in a wooden frame with a picture hanging over if
