300 Biscayne Boulevard Way, Miami, Miami-Dade, FL, 33131

Effective Date	2024-05-03	Inspection Date	05/07/2024
Policy Number	xxxx3709043-00	Policy Status	new
Policy Type	E&S Multi-Peril	Inspection Type	Basic w/RCE
Policy Holder	XXXX	Home Phone	678542xxxx
Property Street	300 Biscayne Boulevard Way	Contact Phone	678542xxxx
Property City	Miami	Business Phone	
Property State	FL	Email	
Property Zip Code	33131	Company	Marsh USA Inc Naples
AOP Deductible	25,000	Agent	xxxx
Wind Deductible		Agent Phone	404-698-xxxx
System	Velocity	Policy Company	Lloyd's of London

Demo Arc

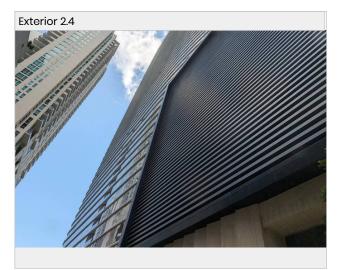
Satellite image used due to height of building
