**xxxx Indian Creek Island Road, Indian Creek, Miami-Dade, FL, 33154**

General Info

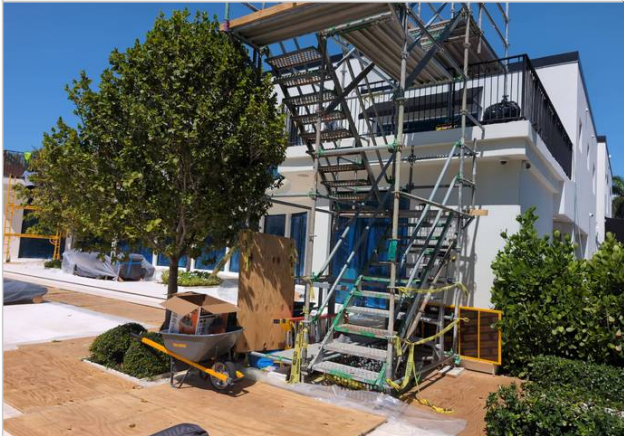
Exterior 2.4

Scaffolding

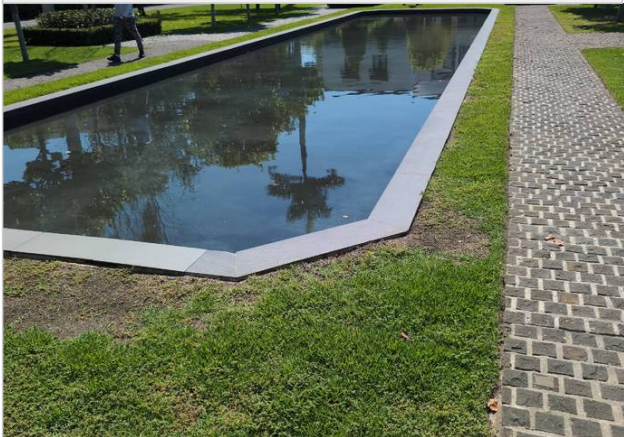
Other 14.1

Pond
