xxxx South Golf View Street, Tampa, Hillsborough, FL, 33xxx

General Info

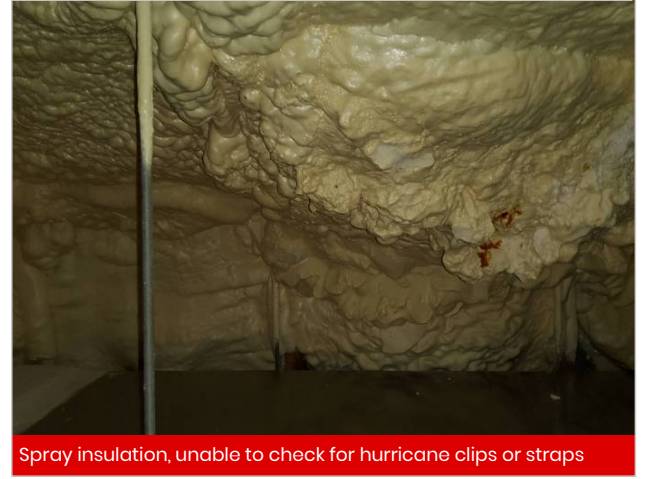
Roof 4.3

Spray insulation, unable to check for hurricane clips or straps

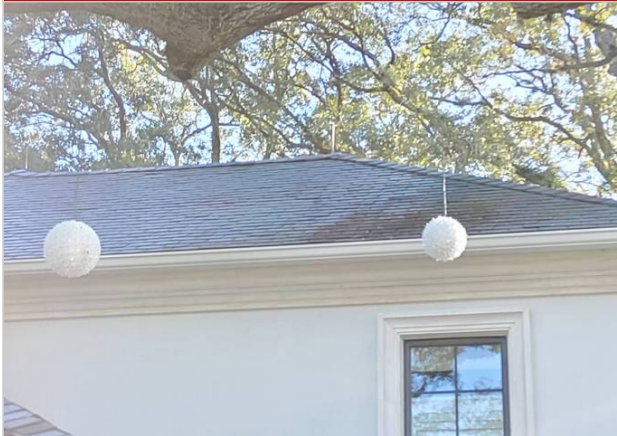
Roof 4.11

Parts of the roof are not in clean condition

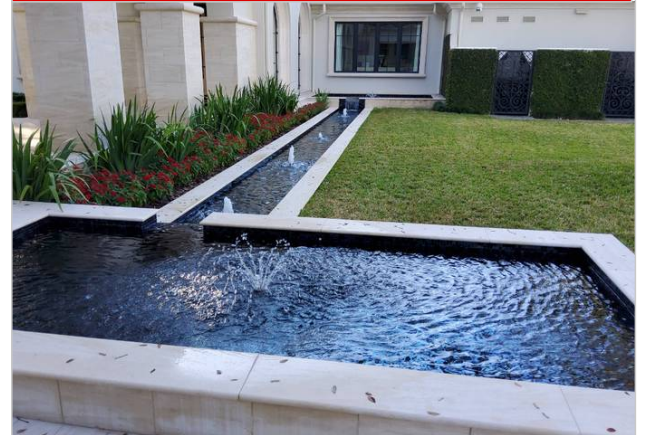
Pool 9.3

Fountain in front of house, with approved fencing.

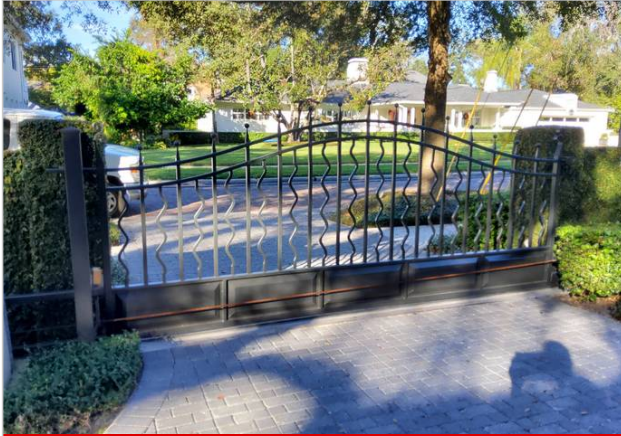
Other 14.1

Gated driveway
