xxxx x Beach Rd, Hobe Sound, Martin, FL, 33xxx

General Info

| Effective Date | 01/14/2020 | Inspection Date | 01/23/2020 |
|---|---|---|---|
| Policy Type | E&S Multi-Peril | Inspection Type | All Inclusive Inspection |

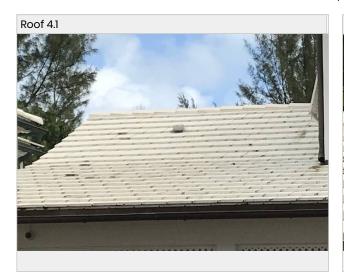
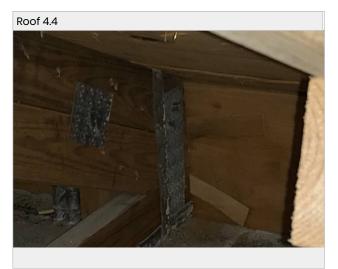
| Inspection Question | Current Information | Inspector Update | Χ | Additional Information |
|---|---|---|---|---|
| 19 Roof Condition | | Poor | | Tiles/shingles broken/missing |

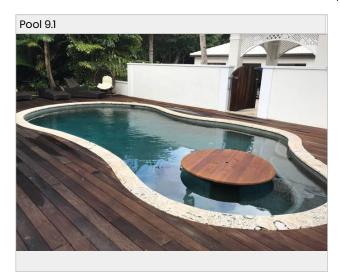
Gate with working Lock

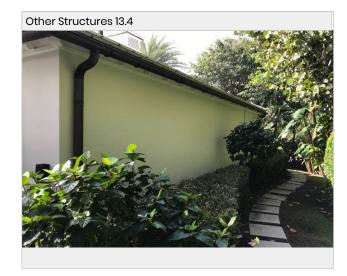
3 door Garage was one of the Other structures found.
