xxxx x Beach Rd, Hobe Sound, Martin, FL, 33xxx

General Info

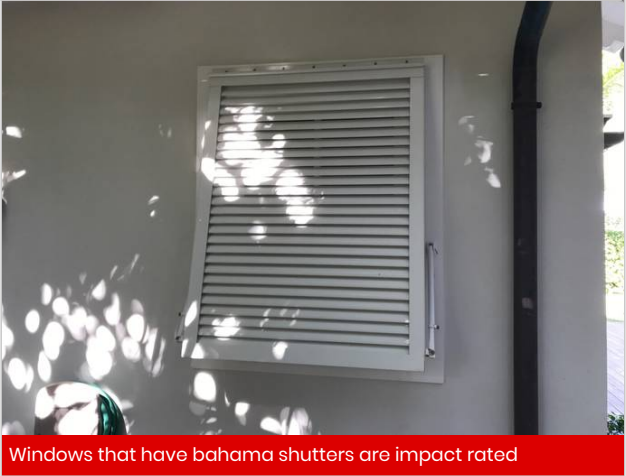
Mitigation 8.2

Concern Type	Information
Property Info	
Exterior	12 Wind Mitigation - "Impact Glass" ("shutters")
Interior	
Roof	17 Roof Geometry - "Complex" ("gable")
HVAC	
Plumbing	
Electrical	
Mitigation	Photo 8.2 - "Windows that have bahama shutters are impact rated "
Pool	
Fire Protection/Alarm systems	
Pets	
Builders Risk	
Other Structures	
Other

Windows that have bahama shutters are impact rated
