xxxx x Beach Rd, Hobe Sound, Martin, FL, 33xxx

General Info

Highlighted Concerns

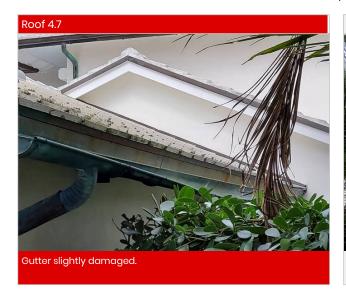
Parts of the roof are not in clean condition, some tiles appear to have been replaced.
