xxxx South Golf View Street, Tampa, Hillsborough, FL, 33xxx

General Info

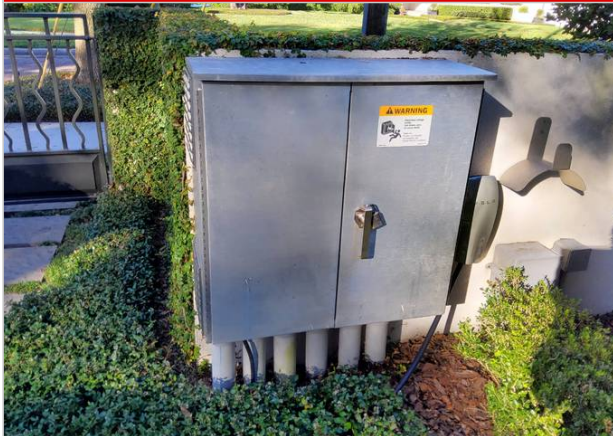
Electrical 7.5

Electrical meters in locked box
